From: "McClain, Ian" <IanMcClain@consolenergy.com>
To: "McClain, Ian" <IanMcClain@consolenergy.com>, "Hardy, Russell" <RussellH...
CC: "SteveChristensen@utah.gov" <SteveChristensen@utah.gov>, "karlhouskee...
Date: 3/31/2009 3:30 PM
Subject: Emery Subsidence report
Attachments: Emery Subsidence 02-2009.pdf

Consolidation Coal Emery Mine Subsidence Report for February 2009

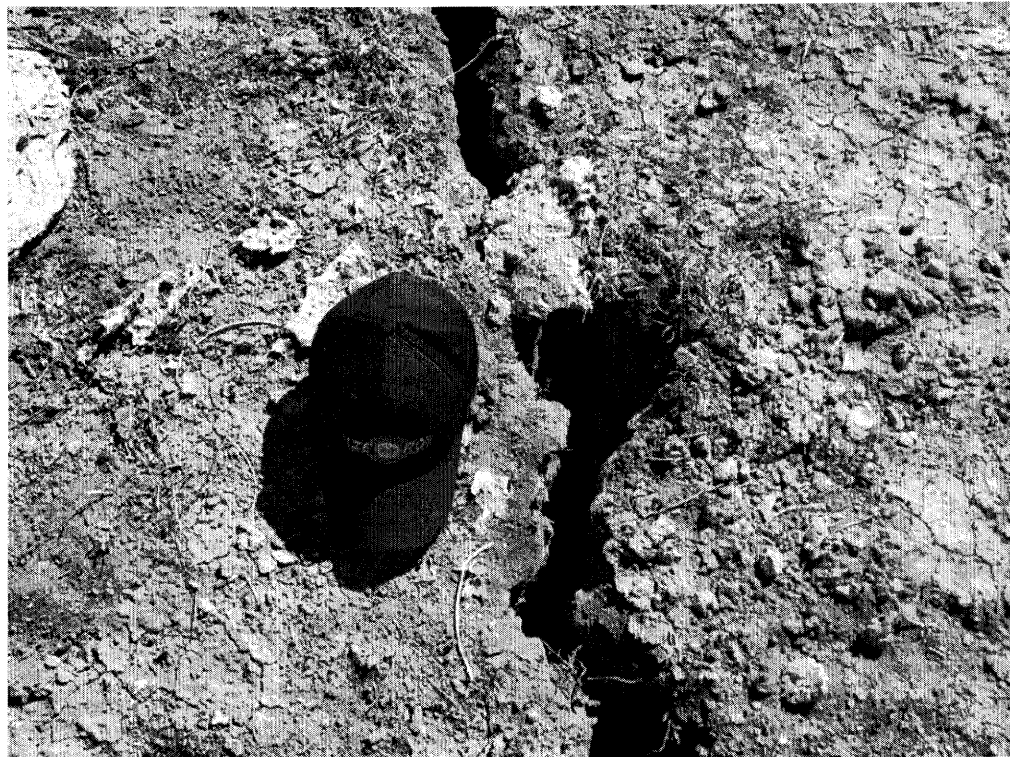
2-25-09 12th West – Underground the area is starting to cave and sag. We went to the surface and found several indications that the ground has moved. On the southwest edge of the panel the cracks appear several inches wide and are approximately 15 to 25 feet long. A series of 2 to 4 large cracks can be found along the southwest edge of the panel. Along the northeast edge of the panel a series of 6 to 9 small cracks were noticed. These cracks averaged ½ inch wide and approximately 5 feet long. Also observed was a stretching and loosening of the fences that crossed the area of the panel. On most fences the top two strands became very tight to where they bent the tops of the fence posts. Conversely the bottom strand was very loose. Pictures of the large cracks on both sides of the panel were taken as well as the fence line. RH & JJ

Crack along southwest side of the panel

3-3-09 12th West – Cracks along southwest side of the panel are continuing to extend with the face position. Cracks on the northeast side of the panel were not found to be extending with the face at the time of the inspection. RH & JJ

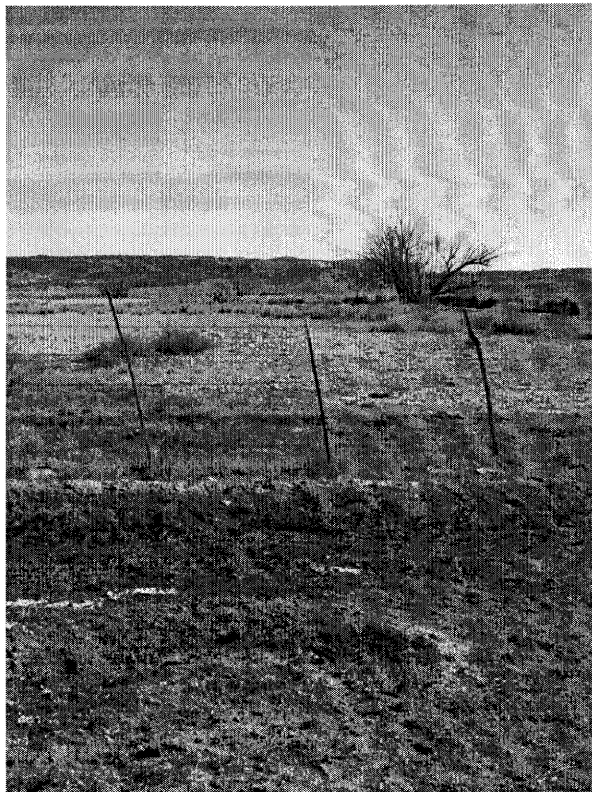
Bowed fence posts above Panel 12 West

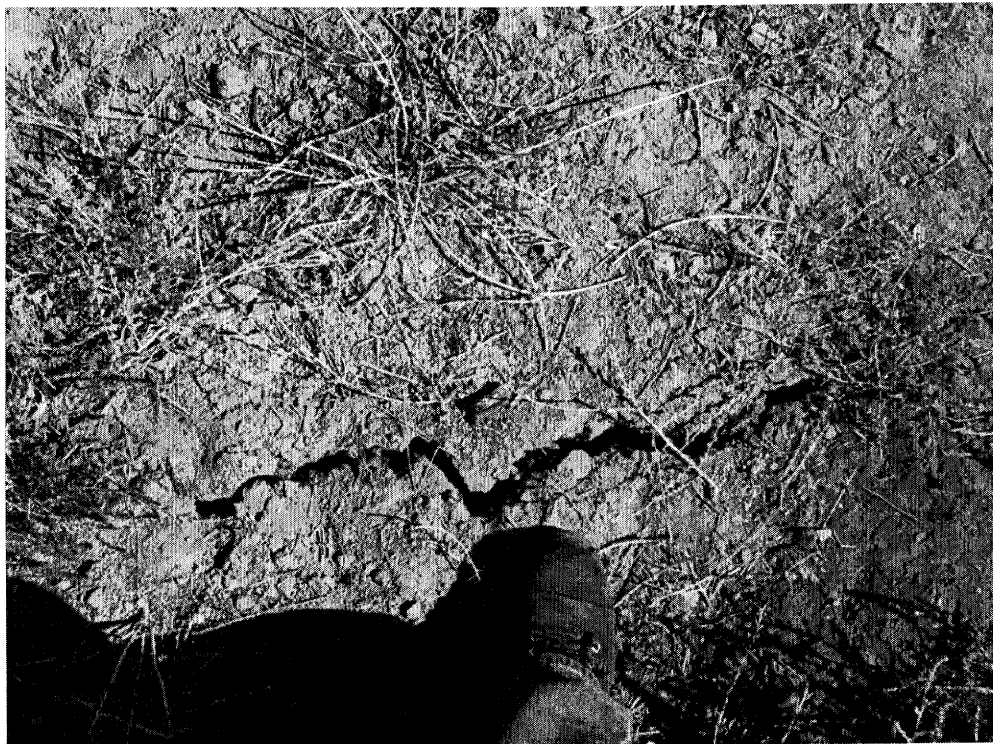
Cracks along northeast side of panel
